Bulletin #: LuK 200503
Issue Date: 18/03/05
Distribution Code: A
Revision Level: 1.0

Service Bulletin

Subject: LuK LF93 Power Steering Pump – Pressure Port Screw Torque

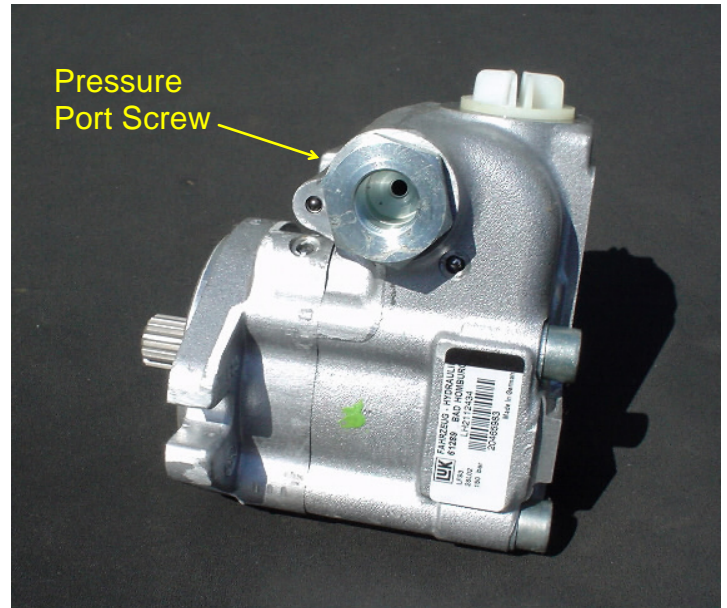
Excessive torque applied to the pressure port screw can distort the flow control valve bore causing a flow control valve malfunction.

Excessive torque may be applied when tightening the hydraulic fitting, particularly if the pressure port screw is not held.

The correct torque is 40 to 50 Nm (30 to 36 ft/lbs).
