Bulletin #:0704001
Issue Date:09/07/2004
Distribution Code: A
Revision Level: 1.0

Service Bulletin

Corrosion of the blind (opposite side to pitman arm) end of sector shaft and sector shaft bearing housing rotation, M110 steering gears.

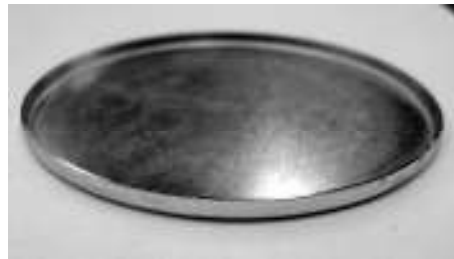
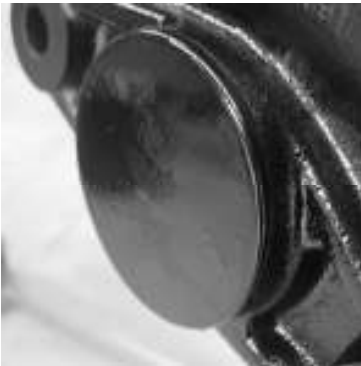
HYD11145 Cover Sector Shaft

The cover replaces the plastic disc that is glued to the main housing as an end of cover the sector shaft. The replacement steel cover is fixed by "Selastic" to the main housing. There is a degree of interference between the lip of the cover and the sector shaft seal boss on the main housing providing a mechanical hold.

Make sure that both surfaces are thoroughly cleaned with mineral turpentine before the "Selastic" is applied. Using "Selastic" ensures that should the output shaft seal leak pressure acting over the area of the cover is sufficient to force the cover away from the housing thereby avoiding applying pressure to the end of the shaft. When installing the steering gear make sure that the metal cover does not foul the mounting bracket of the vehicle frame.

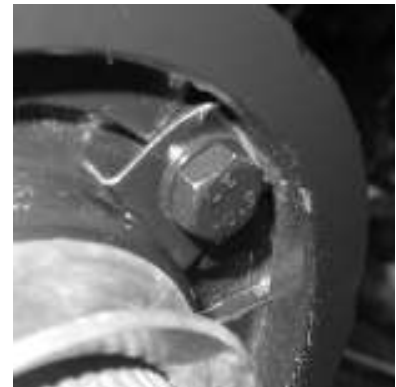
HYD11235R1 Retainer Auxilliary

Three (3) of these auxiliary retainers are used per steering gear and are equally placed as shown in the illustration to the right. The auxiliary retainers are thin enough to use the standard bolt and must be used with the existing 3 piece retainer which still provides the primary lock of the bearing carrier to the

main housing. The sharp edges of the spring steel retainer engage the main housing bore securely restraining the bearing carrier thereby eliminating the tendency to rotate within the housing.

The HYD11235R1 retainer is NOT a substitute for the existing 3 piece bearing carrier retainer and is only used in conjunction.

Both the HYD11145 Cover and the HYD11235R1 should be added during steering gear repairs.
